DRIVE SOLUTIONS FOR OUTDOOR POWER EQUIPMENT

Transaxle Type RS800P

Service and Repair Manual

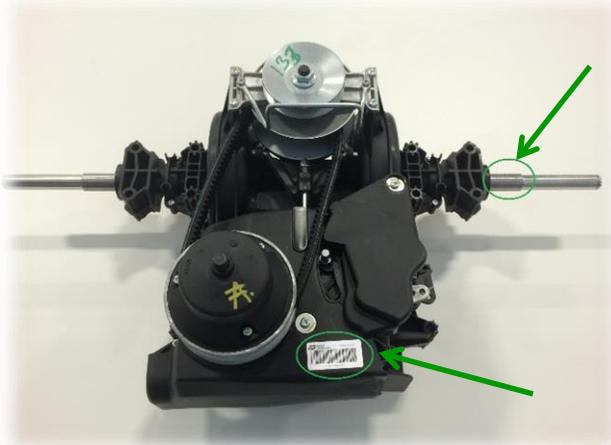
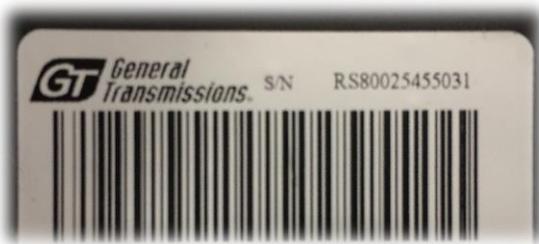
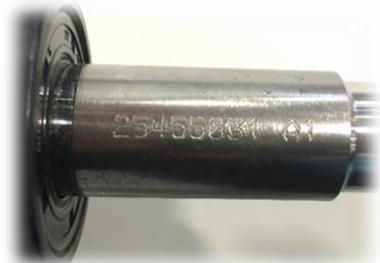
Product identification

-The product identification number is located on the top of the bar-code sticker and engraved on the left output shaft.

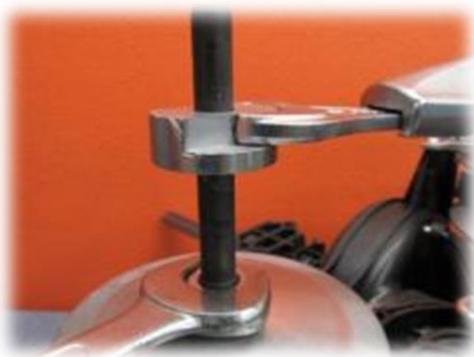
-Unscrew the nut using the special tool P/N 79252 (see p.19), then remove the fixed flange.

Screwing torque: 90 ± 8 Nm
(65 ± 5 lb-ft)

- Make sure the 8 balls are present under the flange.
- Respect the torques of the nut and screws.
- Make sure the belt is properly positioned in the pulley.
- Ensure that the spring is between the mobile flange and the aluminum ramp.

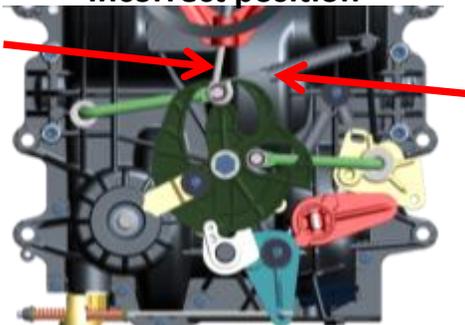
Incorrect position

Variation levers

Adjusting screw

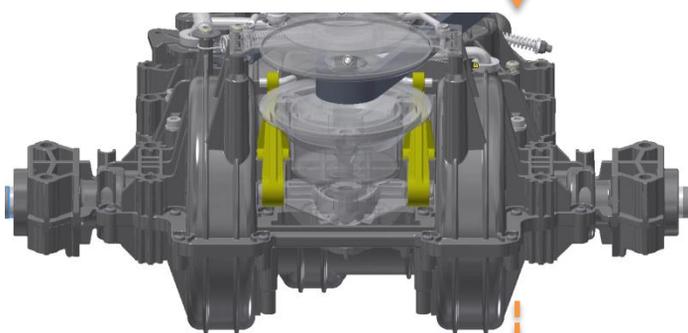
Be careful to place the bearing on this side (screw as on the picture)

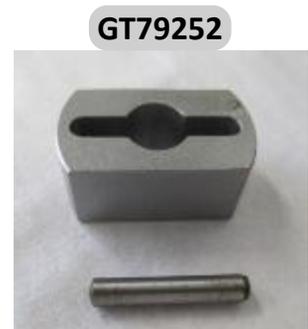
-Special tool is necessary to remove the driven kit GT79253.
 -Refer to the troubleshooting page 7, to know when driven kit must be removed.
